# Safety Inspection Report

Annual Inspection

## Bradley Playground

Bradleys Both Parish Council

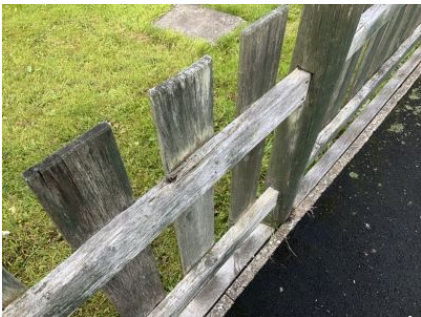
Timber is decayed.

Rails and pales rotting. Monitor and replace as required.

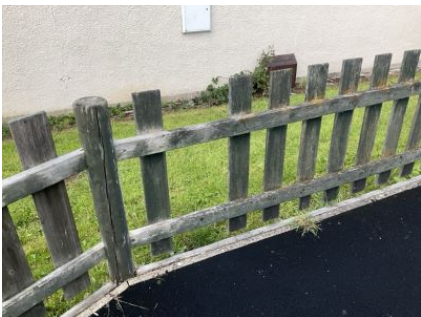
Minor repairs are needed.

Repair.

Replace missing and damaged slats.

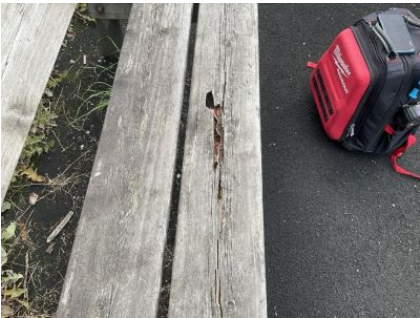
| Timber is decayed. |

| Replace affected parts. |
| Replace rotting bench slat. |

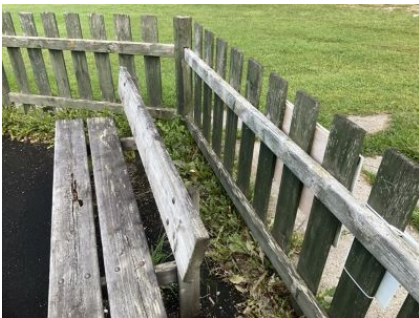
RoSPA recommend a minimum distance of 1 m between seat and fence. This is to reduce the likelihood of children vaulting the fence via the seat.

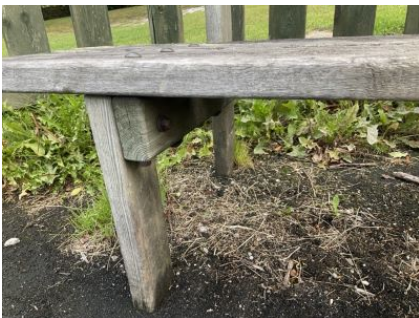
Fixtures loose or missing.

Bench frame and slats loose. Secure.

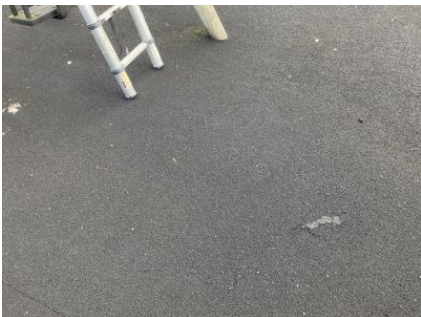
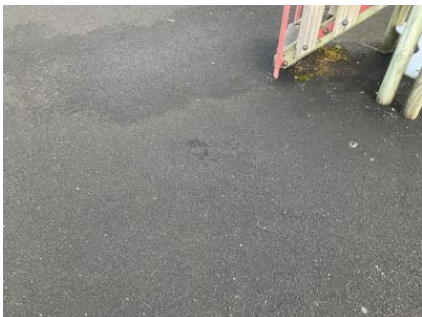
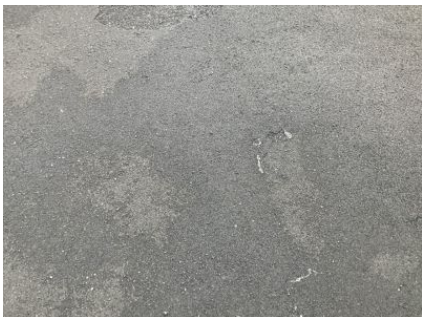
Surface is wearing.

Surface wearing, cracking and holes are forming. Monitor and repair as required.

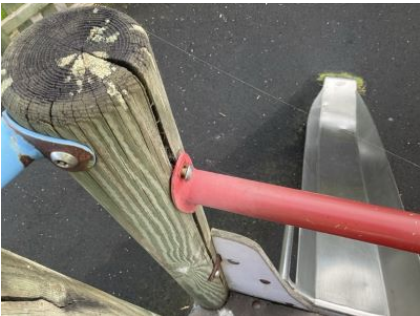
Fixtures loose or missing.

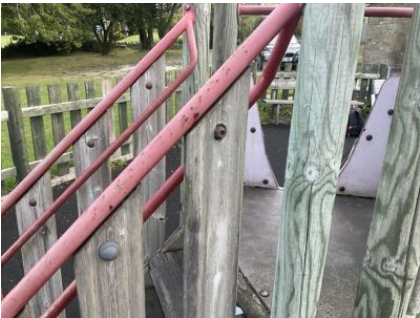
Cap missing.

Replace.

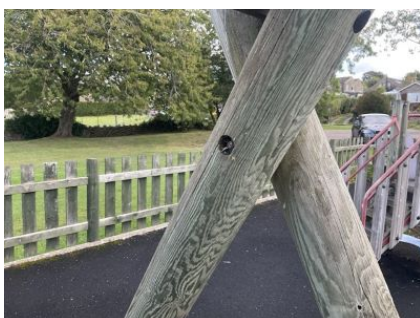
Cap missing.

Replace.

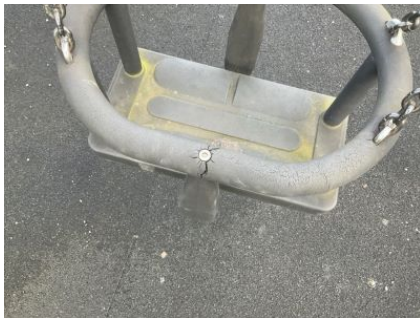
Swing seat rubber is deteriorating / degrading.

Replace when metal is exposed.

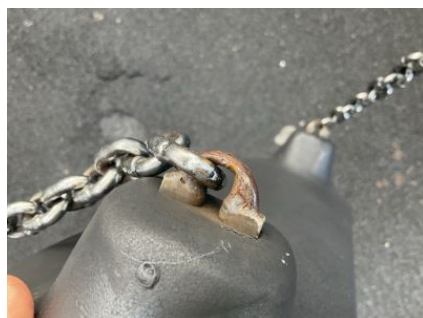
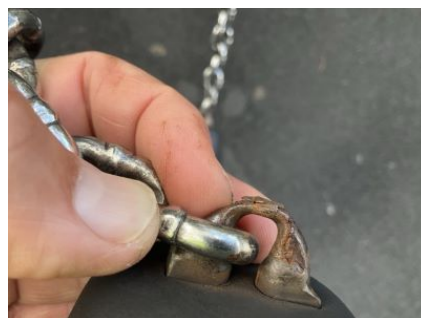
Chain link connectors worn.

Replace worn parts.

Seat connecting links are worn. Replace.

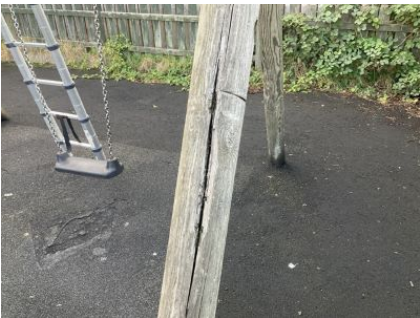
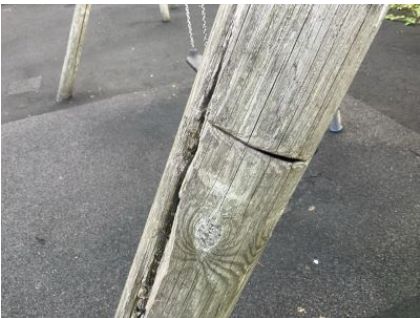
Timber is not in good condition.

The timber around the shakes has been damaged and is starting to soften. We recommend a resistance penetration test is carried out to determine the condition of the timbers.

Read the notes for further action., We recommend resistance penetration testing to determine the internal condition of the timber. We can undertake this testing at additional cost. Please contact us for details.

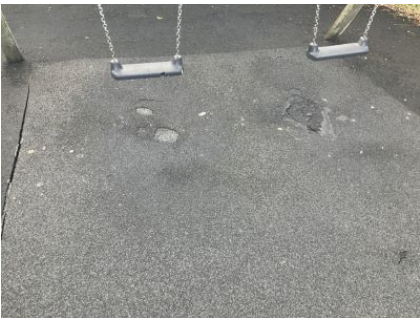
Surface is wearing.

Repair.

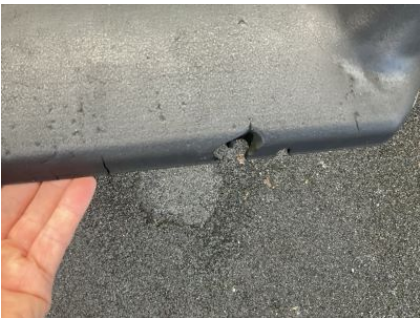
The swing seat has been damaged, but does not require immediate replacement.

Monitor and replace when hard material is exposed.

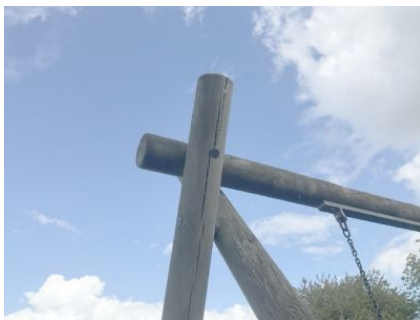
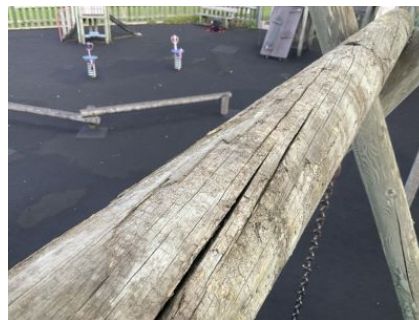
Monitor for decay forming within the shakes on the crossbar.

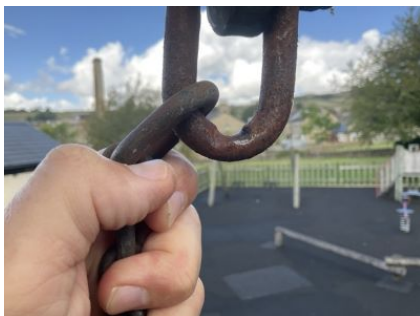
The shackles are starting to wear. Monitor.

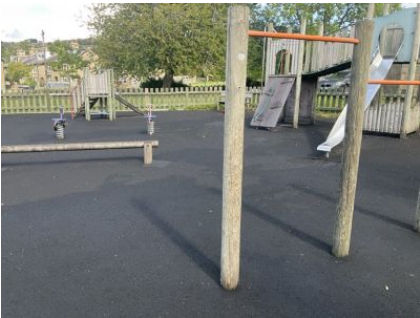
This equipment relies on one post for its stability. Special attention should be paid to maintenance (e.g. by monitoring degradation) and if necessary decommissioning the item before the end of its operating life. This is a requirement of the British Standard.

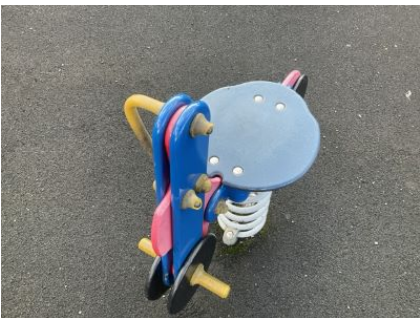
Item is damaged.

Replace damaged hand grip.

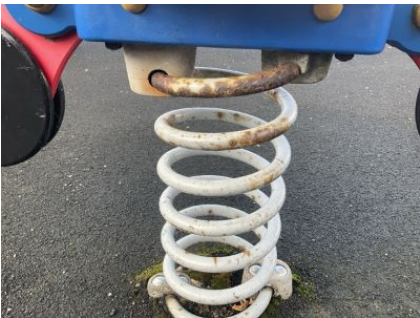
The spring is rusty. These have been known to fail without warning, leading to a collapse of the unit.

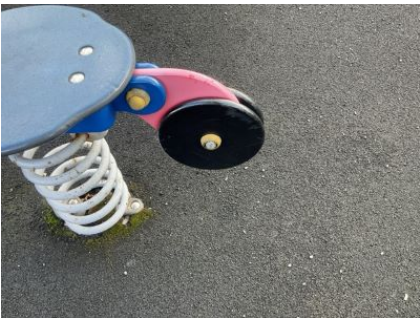
Cap missing.

Replace.

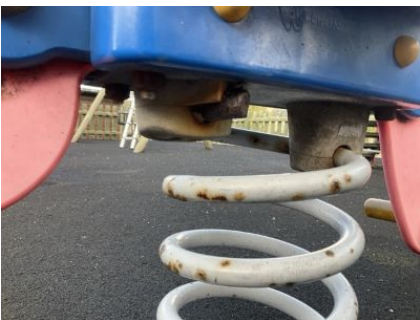
The spring is rusty. These have been known to fail without warning, leading to a collapse of the unit.

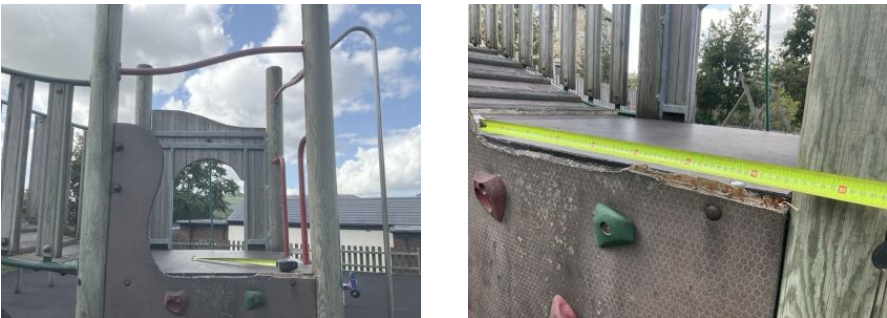
The guard rail is positioned above the maximum of 850 mm. Replace damaged barrier or lower guard rail.

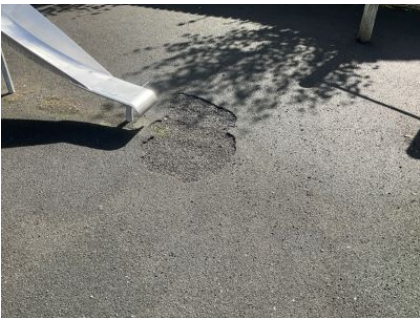
Surface needs repair.

Repair.

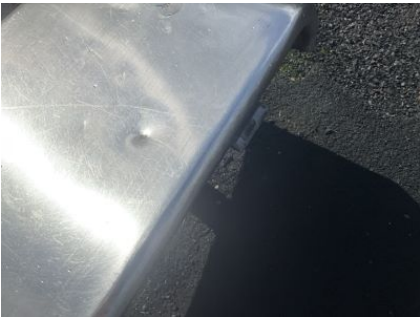
Welds are cracked.

The bottom slide bracket weld has failed, leaving the run-out section loose.  
Repair.

Repair., Read the notes for further action.

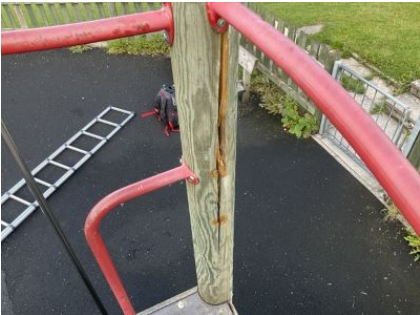
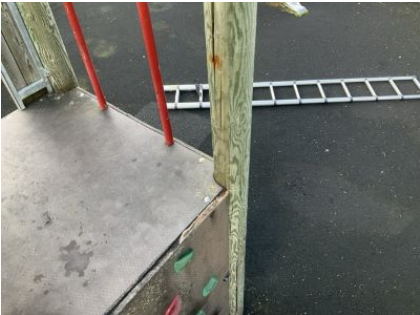
Item is damaged.

Support post and climbing wall panel damaged.

Repair.

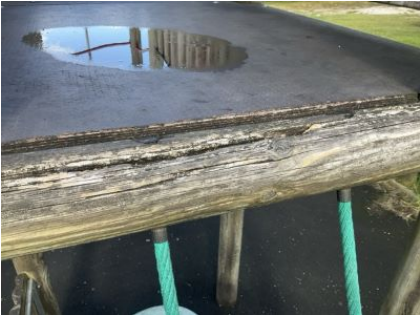
Timber is decayed.

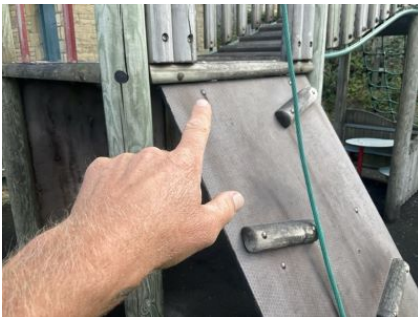
Fixtures loose or missing.

Climbing ramp bracket and climbing pegs loose. Secure.

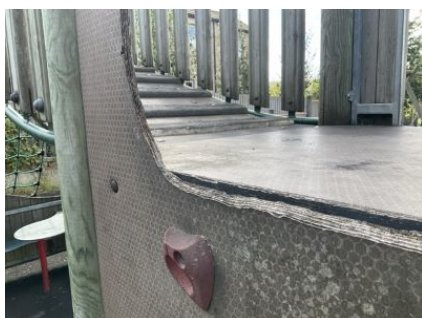
Laminate damaged.

Rub down and treat damaged edges.

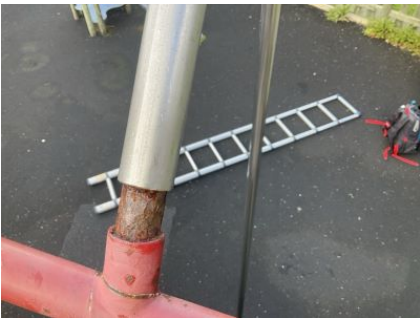
Item is rusting in places.

Table support corroded at ground level and fireman’s pole crossbar. Descale and treat.

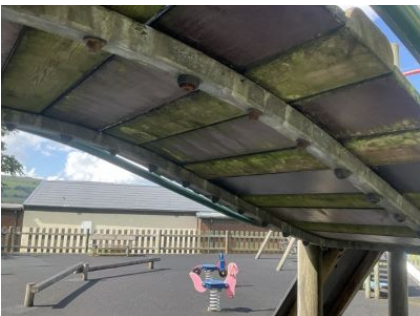
Cap missing.

Replace.
