# Safety Inspection Report

Annual Inspection

## Bradley Playground

Bradleys Both Parish Council

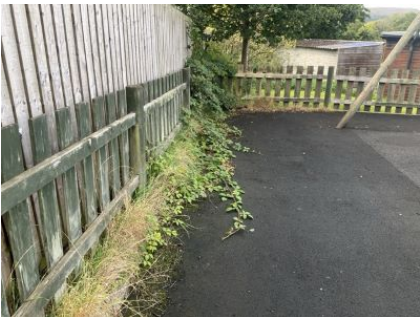
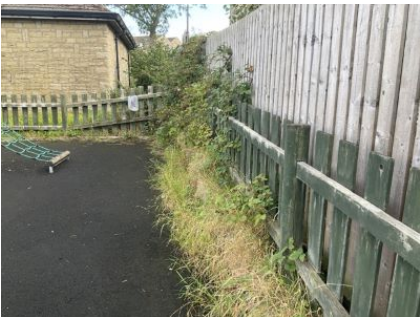
Timber is decayed.

Rails and pales rotting. Monitor and replace as required.

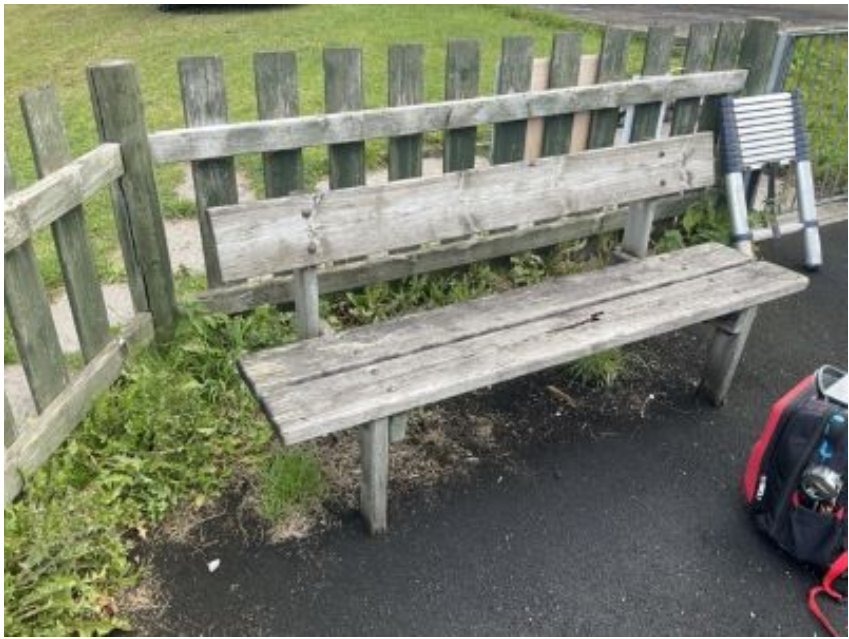
# Seating - Bench

| Timber is decayed. |

RoSPA recommend a minimum distance of 1 m between seat and fence. This is to reduce the likelihood of children vaulting the fence via the seat.

Fixtures loose or missing.

| Replace affected parts. |
| Replace rotting bench slat. |

Bench frame and slats loose. Secure.

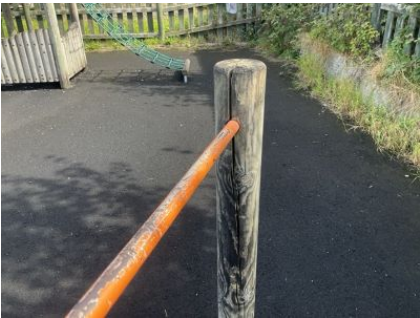
This equipment relies on one post for its stability. Special attention should be paid to maintenance (e.g. by monitoring degradation) and if necessary decommissioning the item before the end of its operating life. This is a requirement of the British Standard.

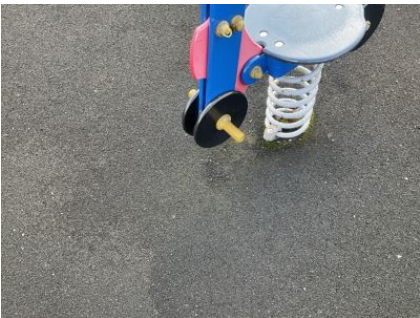
Item is damaged.

Replace damaged hand grip.

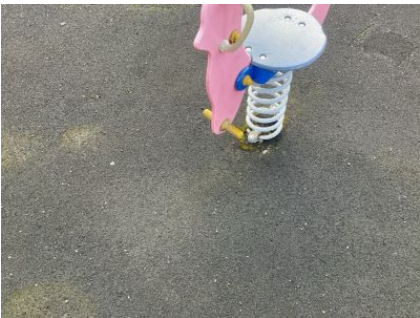
The spring is rusty. These have been known to fail without warning, leading to a collapse of the unit.
